Geraldton Concrete Silos Remediation:

A Case Study in The Structural Strengthening and Concrete Repair Practices Utilised for the Ongoing Operational Efficiency and Durability of Concrete Silos

J Barry, S Robertson & A Mesic
Freyssinet Australia Pty Ltd

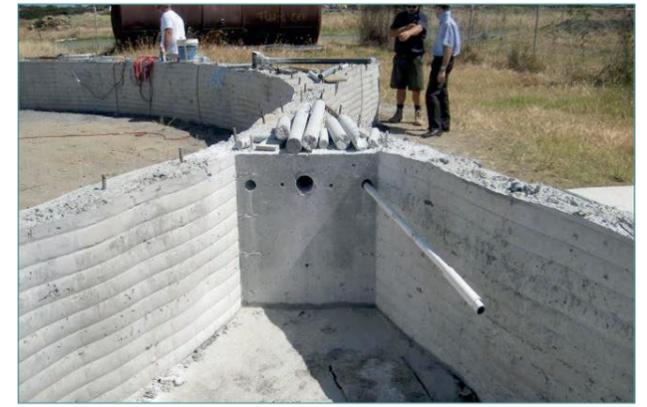
Figure 2 - Cored tendon placement holes.

Coring of primary 90mm diameter holes through the 4500mm long diaphragms was completed with secondary core holes drilled to intercept these, allowing tendons to pass around the full circumference of each circular cell as shown in Figure 2.

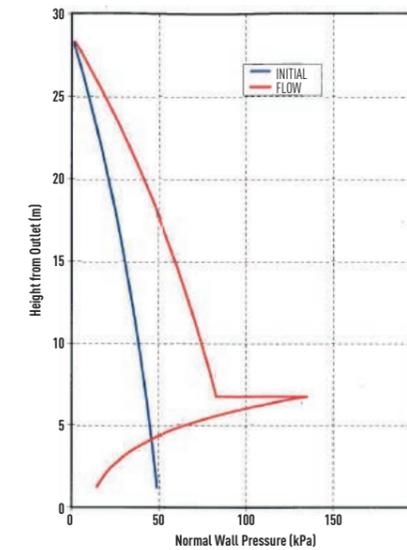
Initial site inspections gave a clear indication of the level of cracking on the silos. Extensive areas were visible where corrosion was evident due to delamination of the concrete and pimples/lateral deformations on some silo walls, as a result of the 'funnel effect' (Figure 4) during the operational use of the silos.

Figure 4 - 'funnel' effect on wall pressure.

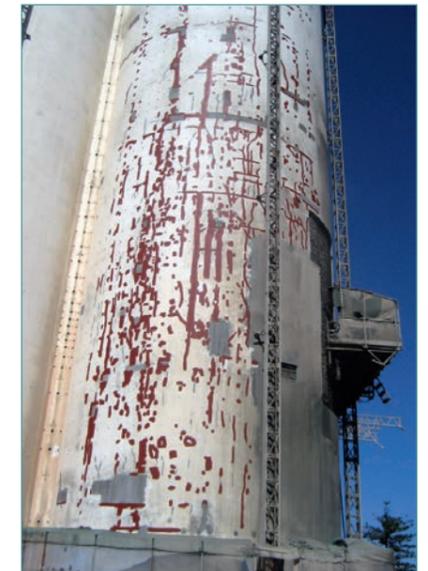
Some remediation works had been carried out previously on the cracking with Kevlar tape placed over each crack to try and stem the cracking and also seal the cracks from the elements. The extent of the cracking exposed can be clearly seen in Figure 5 following removal of the tape as part of the initial repair process.

Figure 5 - After Kevlar tape removal from side of Silo 7.8.

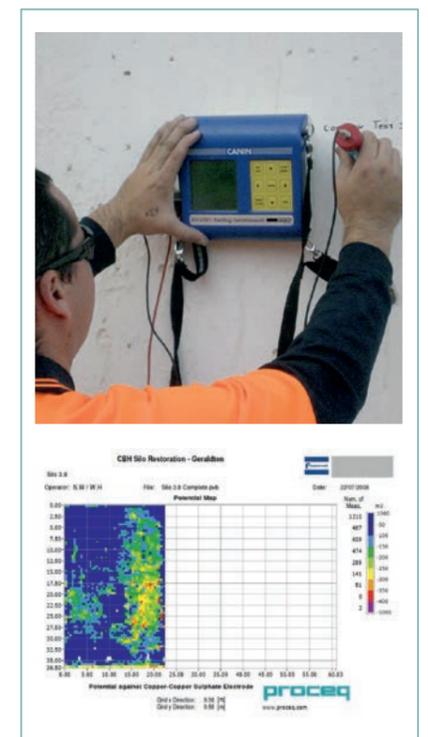
A corrosion survey was undertaken by potential mapping using half-cell testing equipment as shown in Figure 6.

Figure 6 - Potential mapping by half-cell testing.

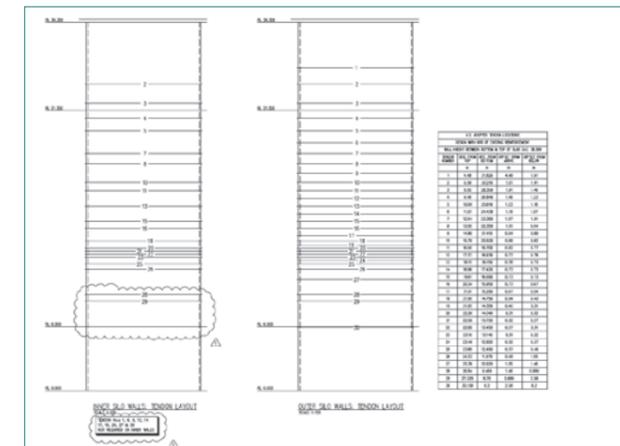
Figure 11 - Tendon layout.

5. Apply concrete repairs to areas requiring reinstatement using a high strength (45 MPa), high strength, low shrinkage dry-spray gunite (Guncrete E) repair application (>600m³).
6. Carry out crack repairs to any remaining structural cracks.
7. Apply a 3-coat high performance water based protective façade coating system to the silo external surfaces (EmerClad).
8. Install an external post tensioning system using diaphragm cored holes to pass each cables external ducting which house the greased and sheathed 15.7mm strand through and around each silo at a pre-determined location (>26km strand). Stainless steel pins were used to support the tendons. Figure 11 shows a typical tendon layout for the silo structural strengthening.
