# Ice and Snow, Away We Go! Painting Ships In Cold Winter Conditions

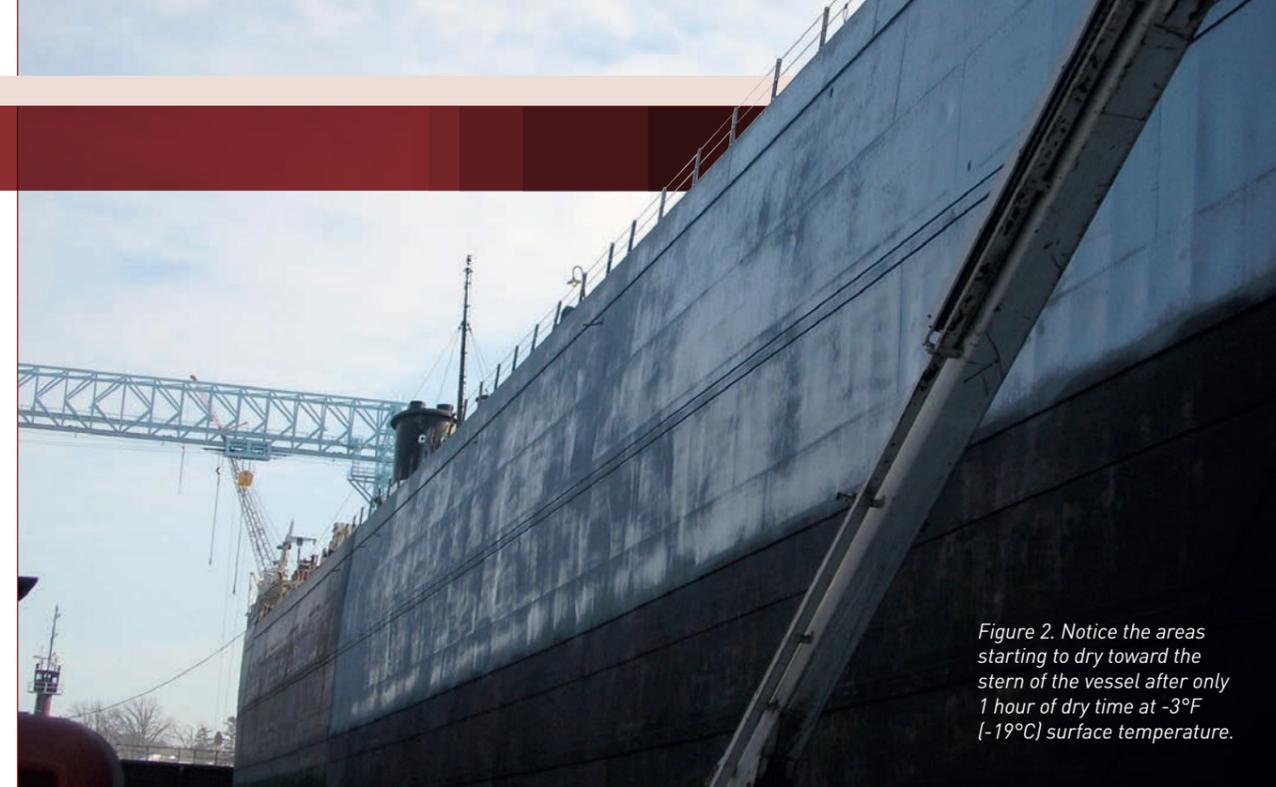
Figure 2. Notice the areas starting to dry toward the stern of the vessel after only 1 hour of dry time at -3°F (-19°C) surface temperature.

Painting application began at 11:45 am. The area was completed at 2:00 pm. By the time the first coat of zinc primer had been completed, the coating applied to the first 50 feet had begun to flash off and was mostly dry to the touch. (See Figure 2) At 3:00 pm a coin rub adhesion test was done to check the integrity and adhesion of the paint film. The results convinced the shipyard to proceed. They began applying the intermediate coat of epoxy at 3:00 pm

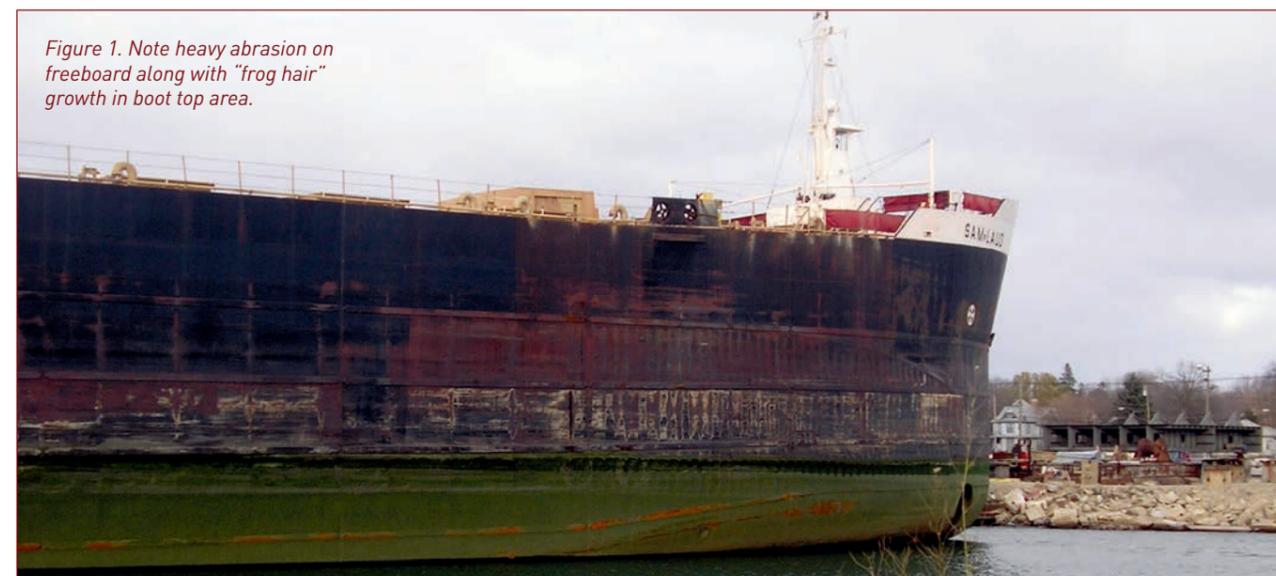
a guide to align the vessel for passage. This heavy abrasion makes for a skinned up freeboard. A heavy build up of "frog hair" marine growth from the deep load line to the bilge turn is also usually present. Fleet engineers want this removed as it can slow the vessel's speed by 1-1.5 knots. With time equating to money, this is an important task to complete (See figure 1).

Figure 1. Note heavy abrasion on freeboard along with "frog hair" growth in boot top area.

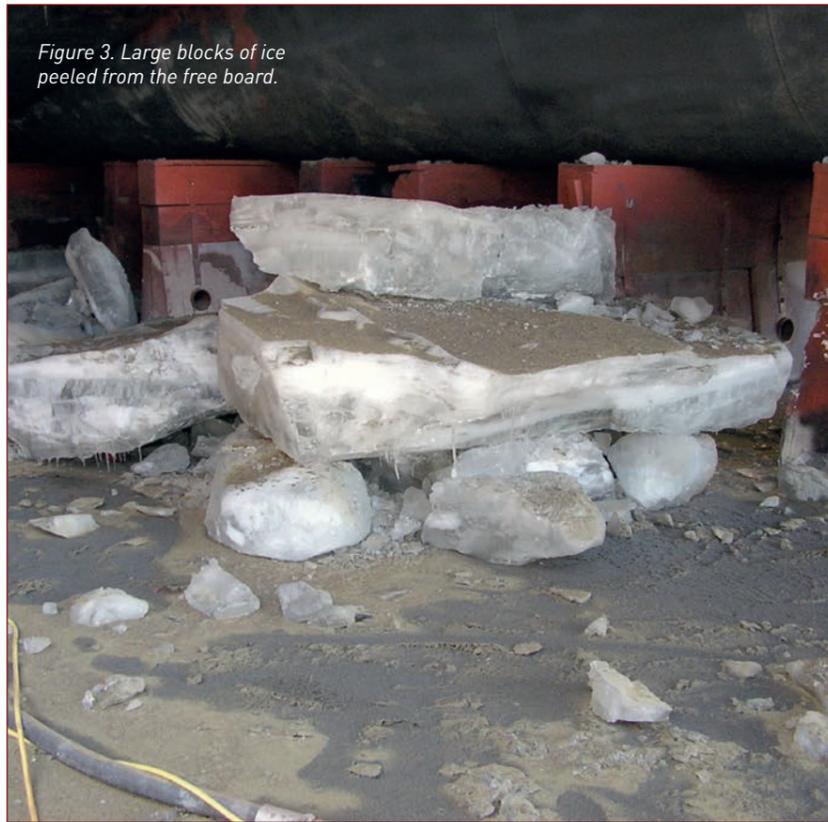
Another challenge faced by northern dry docks in the winter is ice build up on the vessel's hull. After a boat is layed up and sits dockside for its turn in the dry dock, ice builds up on the underwater hull and free board. This can make for some interesting uses of equipment to remove that ice. Some shipyards have a bubbler system in place for waiting boats. That system has marginal success, particularly if the temperature is really cold. The other piece of equipment used to remove ice in preparation for painting is the forklift. After the boat is docked and with ice hanging on the side of the vessel, the operator will take the forks and catch an edge of the ice on the hull. They then move the forks up and have it act as a lever on the edge and remove large chunks of ice. To quantify, the ice is THICK. Many times this build up can be over 12" thick, so this can be a dangerous situation as large pieces of ice are peeled from the hull.

Figure 3. Large blocks of ice peeled from the free board.

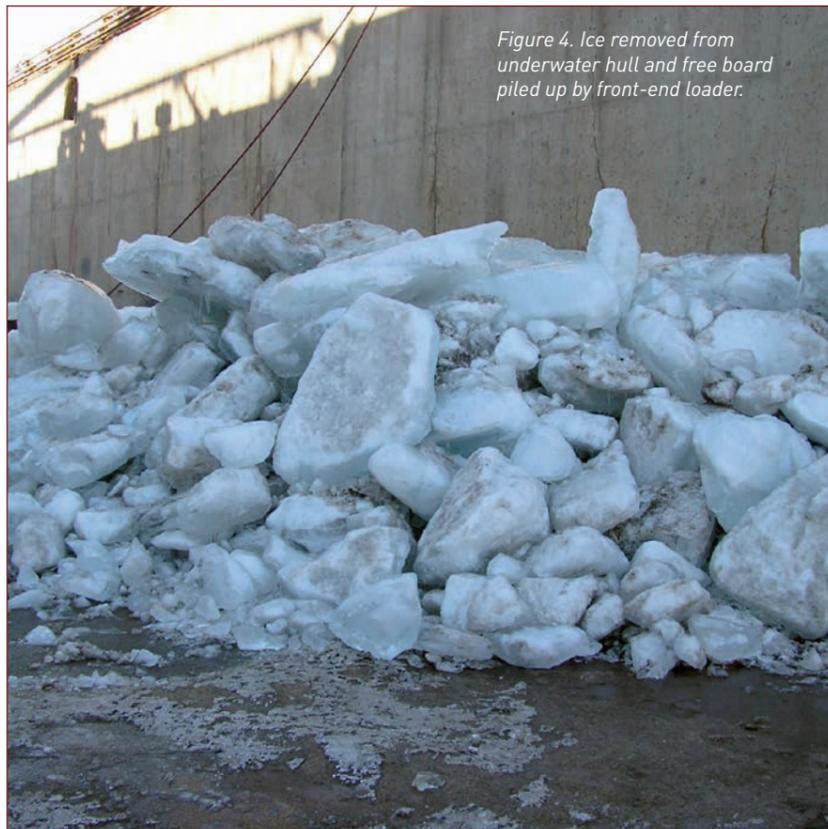
Figure 4. Ice removed from underwater hull and free board piled up by front-end loader.

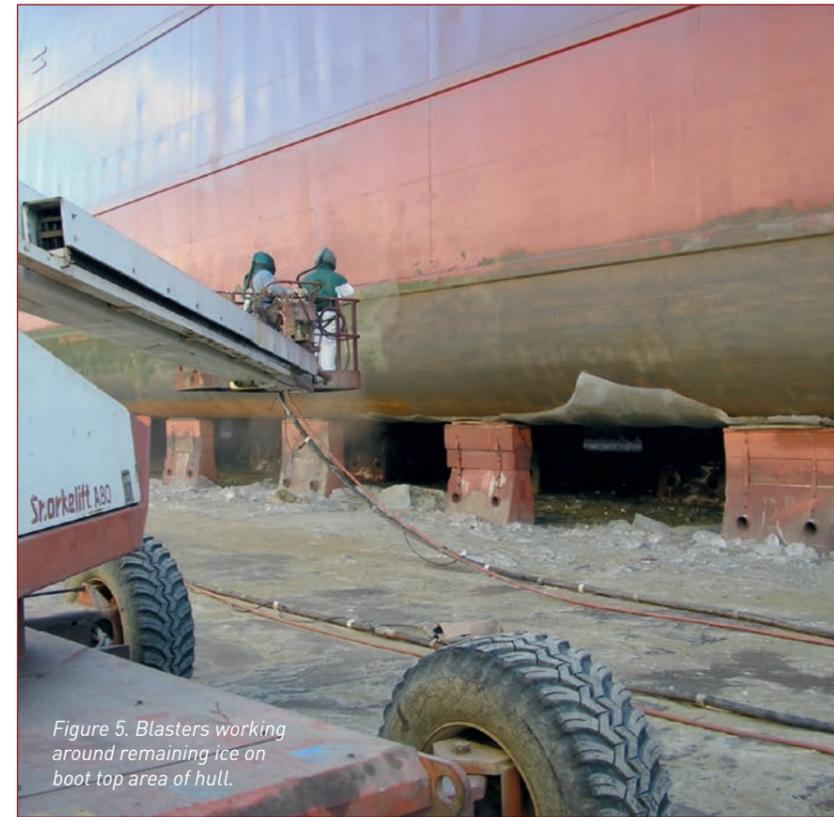
As you can see in Figure 5, sometimes the ice does not come off. In these situations crews work around the ice and those areas just don't get painted.

Figure 5. Blasters working around remaining ice on boot top area of hull.

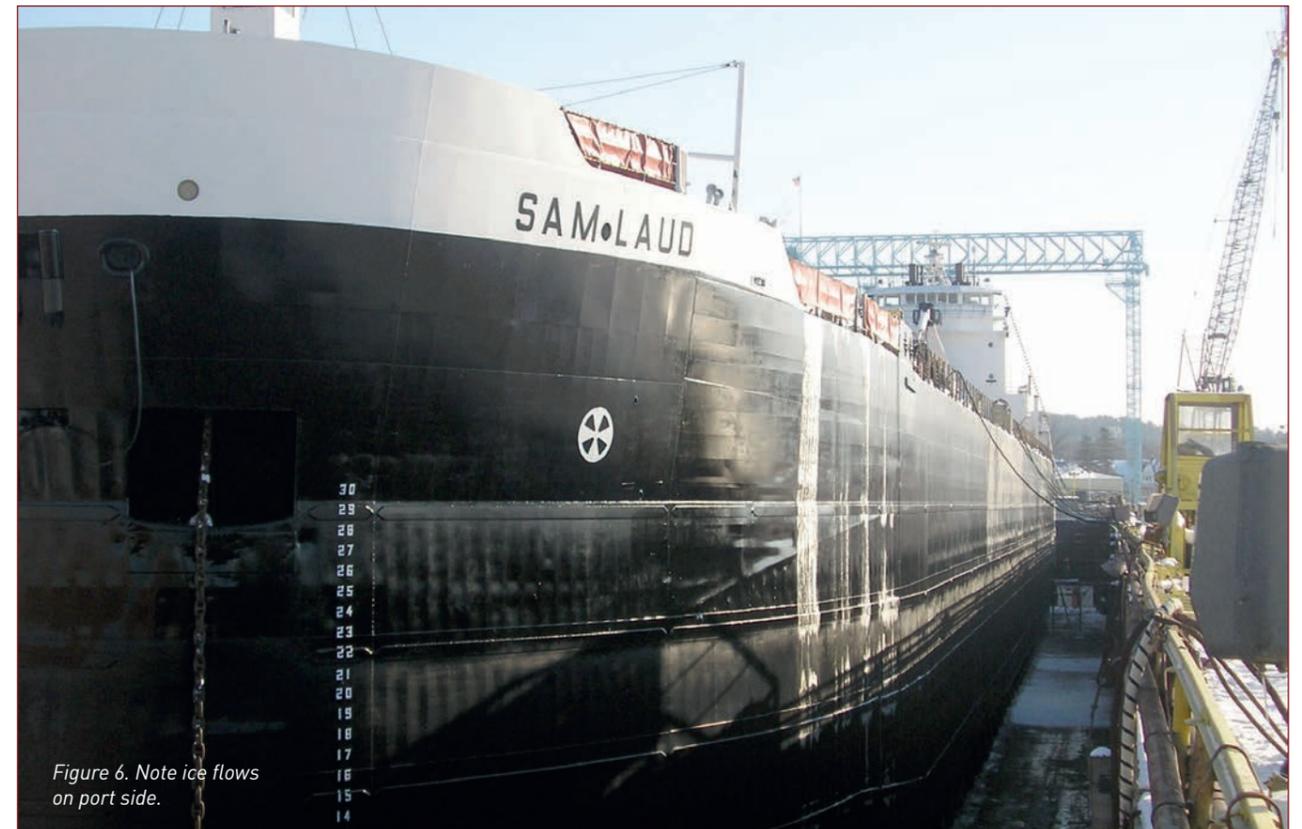
Another interesting contradiction is that the shipyards prefer colder temperatures, that is, in the 10°F to 15°F (-12°C to -9°C) range for this winter work. When the temperature gets too warm the sun heats the deck, usually above freezing. This in turn begins to melt any ice and snow that may have accumulated on the deck. The resultant run off flows over the deck edge and down the side of the free board. Two things happen. The water flows to the dry dock floor, refreezes, and creates an ice rink and the water runs over the deck edge, freezes and creates an ice flow on the freeboard. With an ice flow on the freeboard, painting of those unpainted areas is interrupted and, if freshly painted, those surfaces are usually damaged and have to be repaired. (See Figure 6).

Figure 6. Note ice flows on port side.
