Concrete Problems Today are Multifactorial - Root Causes

by **Hamid Khan**, Brand Manager - Concrete Durability | Parchem Construction Supplies Pty Ltd

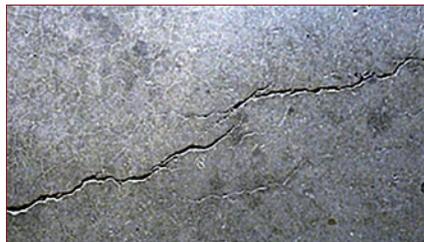
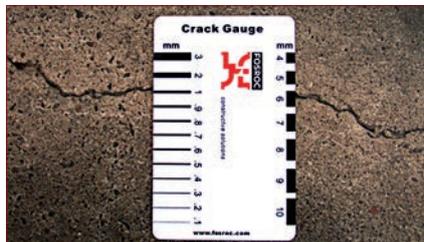
Concrete Cracks provide easy access to corrosive agents.

Corrosion of steel generates iron oxides and hydroxides, resulting in the increase of volume 5 to 8 times of its original size. This increase in volume causes expansive forces to accumulate within the concrete around reinforcement and results in cracking and in areas with low cover, concrete spalling. Cracks provide easier access to oxygen, moisture, chlorides and other corrosive agents that create conditions suitable for accelerating the electrochemical corrosion process. Pretensioned concrete bridge girders may exhibit unexpected end cracking

upon pre-stress release. These cracks may propagate into the bottom flange of the girder where strands are located and can increase in width with increased traffic loads. Leakage from the bridge expansion joint could penetrate the bottom flange cracks and trigger severe corrosion. In this case expansion joint leakage must be arrested prior to the crack and concrete repair activity.

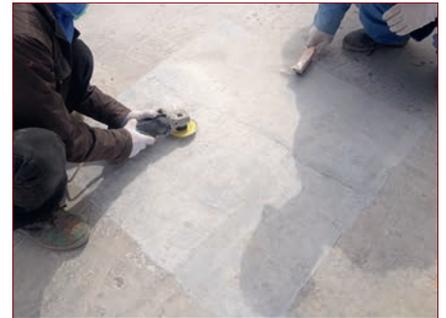
Linear Transverse cracks on new bridge deck due to plastic shrinkage.

A common form of cracking at an early age on new concrete decks is known as *transverse cracking* which may appear over the length of span above transverse reinforcement. These cracks can accelerate corrosion rates, reduce the service life of the asset and increase maintenance costs. When a mass of concrete that shrinks as it ages is restrained, cracks will occur. For example, restraint of a concrete deck by an integral support girder against its volume change initiates cracking. Multiple factors such as concrete materials and mix design, ambient temperature changes, humidity, bridge design characteristics and construction practices can all contribute to volume change and/or to degree of restraint of concrete mass. However transverse cracking cannot be attributed to all of the above factors. It is therefore important to identify the major contributing factor(s) to address the root cause of cracking.

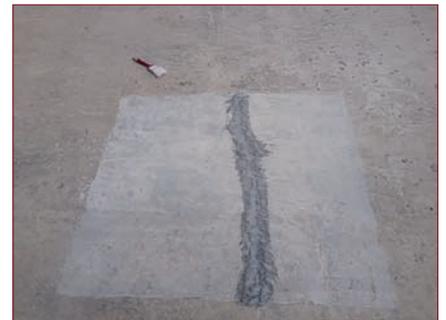
Surface grinding to open the face of the crack and sealing with epoxy resin.

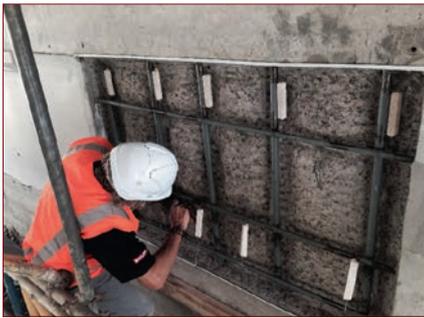
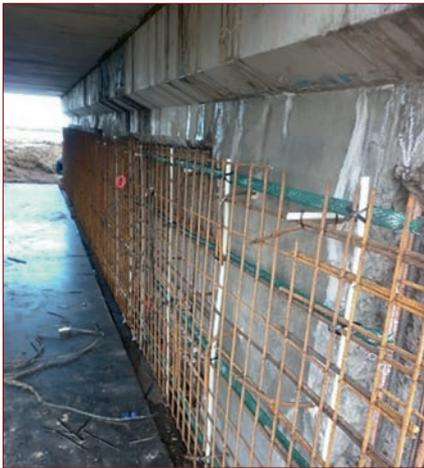
Cathodic protection to bridge piers affected by cracks, corrosion and spalled concrete, using embedded galvanic anode units (top) and distributed galvanic anode system (bottom).

A crude approach while examining the corrosion induced damage in bridge structures, particularly in the marine environment, is to assume the presence of chlorides as the main cause of failure. Chlorides might be the reason of corrosion but not the actual cause of the bridge defect. The root cause of failure of the bridge structure cannot be simply corrosion. There are many factors involved that could lead to corrosion and ultimately lead to failure of the bridge, such as, cracks in bridge girder web and flange, poor bridge drainage system, failed bridge deck waterproofing membrane, inappropriate bridge joints, void in the prestressed or post tensioned cable ducts due to excessive grout bleed. Other factors at macro level are related to design, material, environment and construction practices. It is important to address the main contributing factor(s) of the defects in bridge structures affected by corrosion.

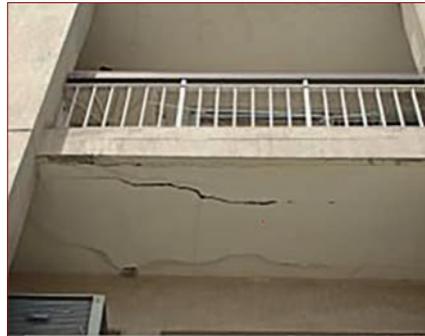
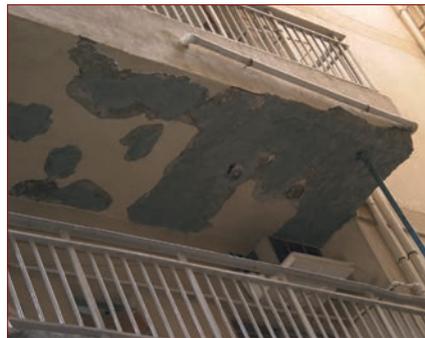
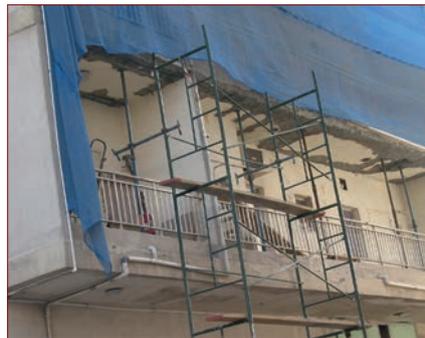
Repair of balcony concrete corrosion and spalling due to multiple factors.

Concrete repairs conducted without considering the actual source are 'cosmetic repairs' and may last only for few months. For instance, repairing the spalled concrete of a balcony with quick-fix patch method, even applying the best quality repair mortar, would not solve the problem unless the root cause has been identified and addressed. It could be attributed to more than one cause such as leakage due to failure of waterproofing membrane, a broken drain pipe, leaking concealed pipe joints or a combination of these factors. Corrosion of reinforcement that has caused spalling of balcony is not the root cause here.

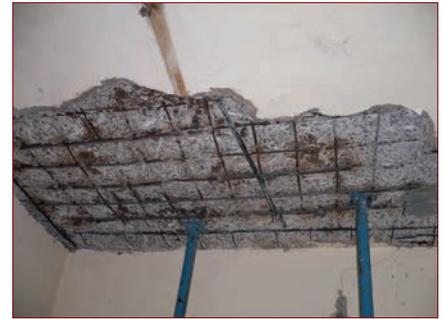
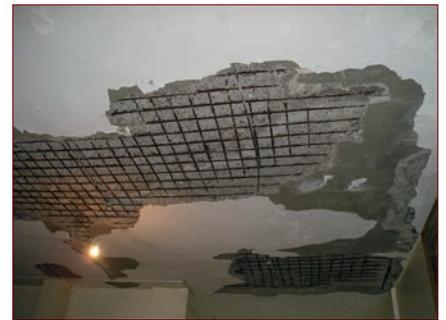
Soffits severely corroded due to roof leakage into a residential building.

Roof leakages in buildings result in seepage into the rooms below. This causes discomfort to the occupants and frequent disputes between the landlord and the tenant in regard to the liability for repair. The failure of roof waterproofing is often attributed to the poor workmanship. Based on this notion, the roof refurbishment is carried out but the leaks appear again after some period of time. Research conducted by Lo, Leung and Cui (2005), on roof construction defects have highlighted that the root cause of failure of the roof waterproofing membrane stems from the roof parapet wall cracks. It further concluded that the design and choice of material for a roof parapet wall is critical to avoid waterproofing membrane failures on the roof slab. Other reasons for roof leakage could be wrong termination details of the waterproofing membrane at up-stands and drains, improper selection of the waterproofing system and poor roof joint detailing.
