Case Studies of Waste Water Structure Rehabilitation – Products, Methods & Outcomes

Case Study 1 – Rehabilitation of a sewerage manhole using a mechanically anchored high density polyethylene liner.

Case Study 2 – Rehabilitation of a sewerage drop structure using a chemically anchored PVC Co-Lining System.

Case Study 3 – Rehabilitation of a sewerage drop structure using a Calcium Aluminate Cement (CAC) Mortars

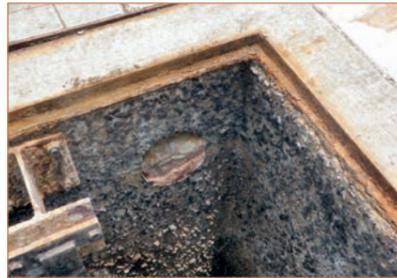
Photo 1 – Photograph of an un-protected concrete waste water structure showing initial signs of concrete degradation.

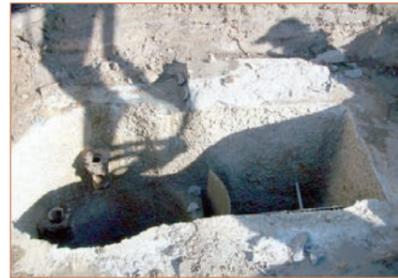
Photo 2 – Sewerage manhole following removal of the top slab and before rehabilitation.

The main steps of the rehabilitation process in this circumstance were as follows:

1. Concrete surfaces water-blasted to remove all contaminated concrete.
2. Liner sheets are cut to size, prefabricated where necessary and placed into position.
3. Lightweight formwork installed to secure the liner position during grouting operations

4. Cast liner into position by pouring grout in the annulus between the rear of the liner and existing substrate.
5. Removal of lightweight formwork.
6. Thermoplastic welding of joints in the liner.

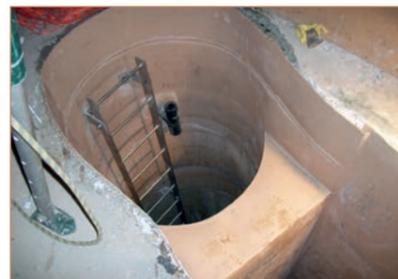
Photo 3 – Sewerage manhole after rehabilitation utilising mechanically anchored HDPE liner.

HDPE liners are a robust concrete protection system designed to protect concrete structures in chemically aggressive environments, the cast in liner sheet allows for reinstatement of defective concrete areas during the casting process and is easily customised to complex structure geometries.

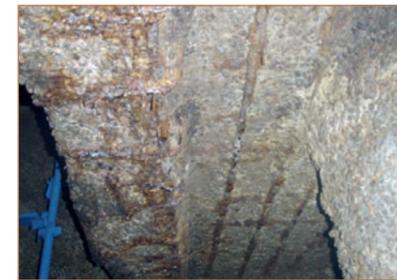
Photo 4 – View of the underside of a concrete platform within the drop structure prior to repair.

The main steps of the rehabilitation process in this circumstance were as follows:

1. Concrete surfaces water-blasted to remove all contaminated concrete.
2. Reinstatement of deteriorated concrete areas to the original structure profile.
3. Liner sheets cut to size and activated.
4. The concrete substrate is primed for installation.
5. Structural polymer is trowel applied onto the substrate.
6. PVC sheets are laid into position on the layer of structural polymer.
7. Lapped joints in the PVC sheet are sealed with the installation of a sheet bridging seam material.

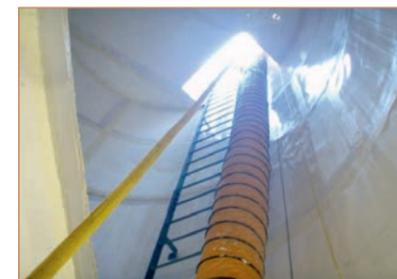
Photo 5 – View from the underside of a concrete platform within the drop structure after repair.

PVC co-lining systems combine the most desirable elements of different materials to provide a level high level of concrete surface protection. The PVC top layer provides a pinhole free

extruded membrane which has very good resistance to permeation by most gasses and fluids. The intermediate layer of the system, which is a structural polymer, provides both an extremely effective chemical anchoring and back up protection to the PVC top layer. A cross link activator creates a molecular bond between the PVC and the structural polymer. The structural polymer additionally penetrates the topmost layer of the concrete substrate prior to polymerization which forms a saturated zone which is part concrete and part polymer.

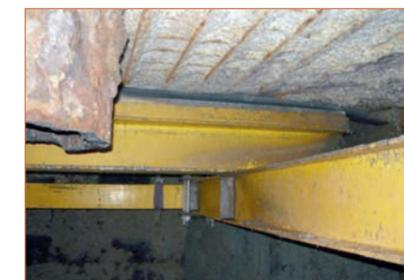
Photo 6 – View of the underside of a concrete platform within the drop structure prior to repair.

The main steps of the rehabilitation process in this circumstance were as follows:

1. Concrete surfaces water-blasted to remove all contaminated concrete.
2. Installation of stainless steel reinforcement.
3. CAC mortar spray applied to reinstate defective areas.

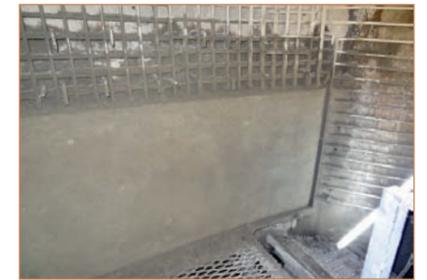
Photo 7 – View of wall within the drop structure being reinstated using a dry spray applied CAC.

CAC mortars provide resistance to biogenic corrosion through its composition of calcium aluminate cement and calcium aluminate aggregates.
