Moisture as a cause of CUI

By Andy Hoffman

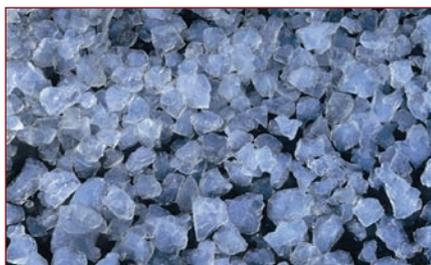
Aerogel in its unhydrated state.

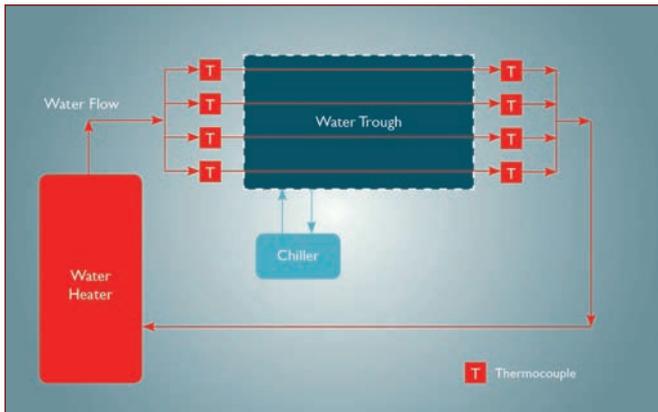
Figure 1: Thermal performance test set up.

The test consisted of a 1.5 m trough that could be filled with water and drained. Copper pipes, 50 mm diameter with a total bent length of 1.8m, were insulated with the appropriate materials. Thermocouples were installed on the inlet and outlet of these pipes in order to monitor the individual efficiency of each pipe. The thermocouples recorded the water temperature as it came into the pipe and also as it left the pipe. A water heater pumped 60°C water through the copper pipes, and a water chiller

was used to maintain the water in the trough at 10°C when flooded. This ensured consistency in the water temperatures being circulated through each pipe. Figure 1 is a diagram of the test set up and Figure 2 shows the test trough with bare copper pipes.

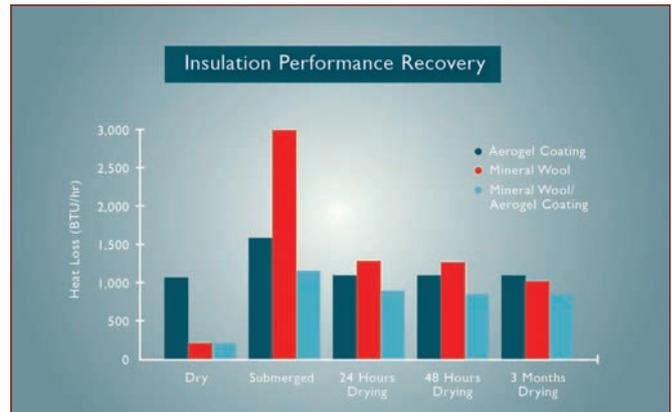
Figure 3: Insulation Performance Recovery.

As expected, the initial dry performance of the mineral wool was significantly better than the aerogel coating. Even though the performance rating of the aerogel coating is slightly better, the mineral wool was installed 20 times thicker than the coating (Figure 3).

The test data became interesting once water was introduced into the trough. The heat loss performance was first measured while submerged in water, showing a drastic spike in heat loss on the mineral wool pipe. The submerged data was telling, but the main purpose of the testing was to see how these materials reacted to getting wet and the impact on their long-term performance.

Twenty-four hours after draining the water from the trough, the aerogel-coated pipe had returned to its original heat loss performance while the mineral wool struggled to dry out and regain some of its original dry performance. Ultimately, after having a full three months to dry, the mineral wool still was losing five times more heat than its original performance.

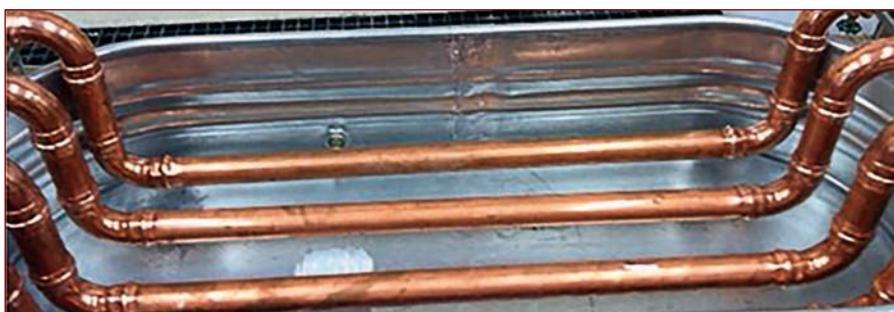
Figure 2: Test trough with bare copper pipes.

Before installing any of the insulation materials, the bare pipes were run dry for several days to establish a baseline and to demonstrate consistency across the various positions in the trough. As expected, heat loss from the pipes increased dramatically when the trough was filled with water. Once the water was drained from the trough, the bare pipes returned to their initial dry performance within a few hours.
