STRUCTURAL CORROSION ISSUES ON COLLINS CLASS SUBMARINES

**Mr. Roman Dankiw
Senior Technical Officer
Directorate of Submarine Engineering
Structural & Naval Architecture Group**

Summary: This paper is a modified summary from a study conducted by the Submarine Branch to identify and quantify the impact of corrosion on the Collins Class platforms during major maintenance activities. The results of the study led to prioritising and targeting the strategies needed to minimise corrosion and hence reduce the cost of ownership and increase platform availability.

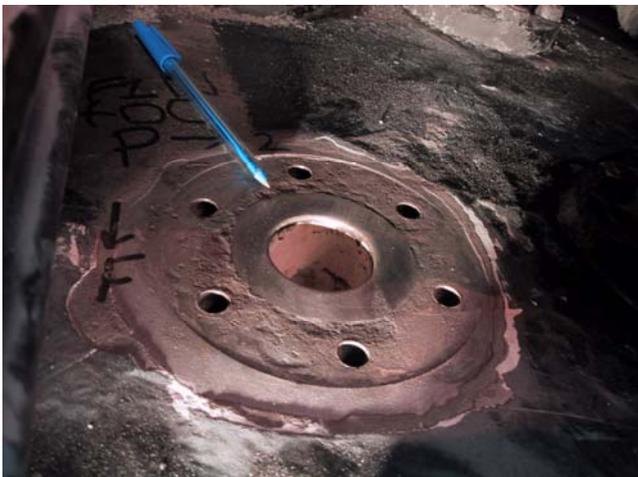
Photo1- Electrical Hull Penetration -bolted joint

- Electrical Hull Penetrations PHPs- (photo 1 Annex D)-bolted joint-galvanic and crevice corrosion.
- Bilges (photo 4 Annex D)- severe pitting corrosion due to localised coating damage.
- Battery Compartments (photo 5 Annex D)-severe pitting corrosion due to localised coating damage.
- Body end Valves- (photo 3 Annex D)-bolted joint-galvanic and crevice corrosion.
- Seawater flood areas- Stern Tube, SSEs (photo 6 Annex D-galvanic corrosion), Torpedo Tubes, Free Flood Spaces.
- Hatches
- Tanks
- Shaft seal
- Mechanical Hull Penetration Forgings (photo 2 Annex D-galvanic corrosion)-design change already completed, changed from a Nickel coating to Inconel cladding.

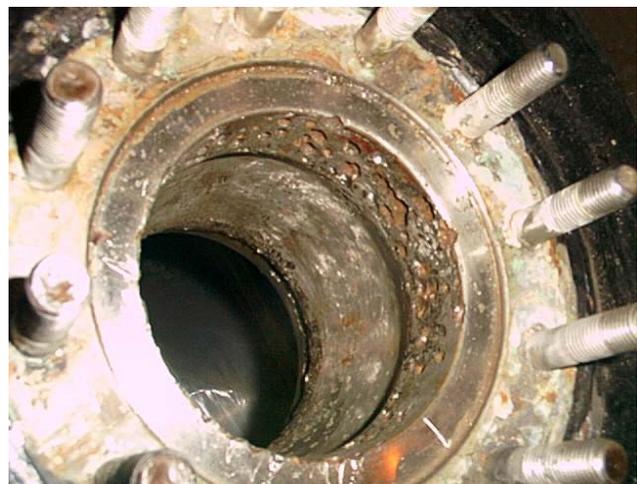
Photo 2- Mechanical Hull Penetration

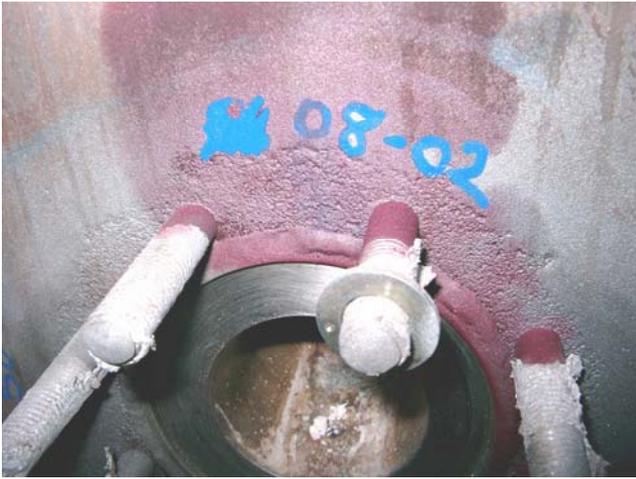
Photo 3- Body End Valve- bolted joint

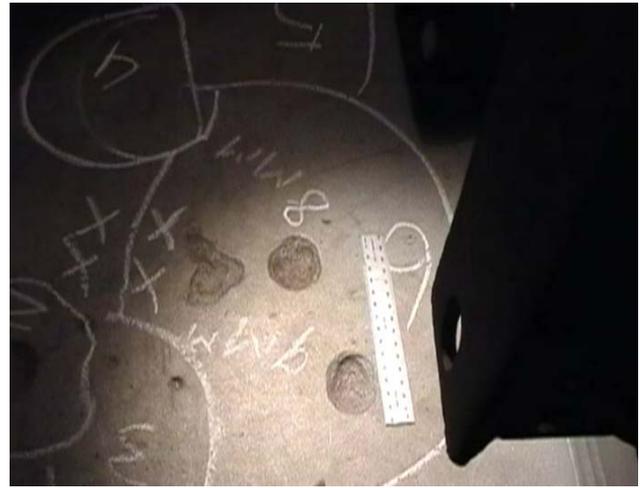
Bilge Plating up to 10mm metal loss on hull plating in the 4 Bilges	YES	-Galvanic Corrosion -Differential aeration -Coating damage -Suspected Biological corrosion	-Design does not factor in damage to coatings during maintenance -Design does not factor in access for inspection and ease of coating repairs -Bilges not cleaned regularly	1.2
Flood Areas Several millimetres metal loss on the Stern Tube, SSE's and Torpedo Tubes	YES	-Galvanic Corrosion -Differential aeration -Coating detachment	Complex geometries and sharp edges Poor choice of protective schemes (SSE's)	0.8
Body End Valves- up to 3mm metal loss on plating	YES	-Galvanic Corrosion	Detail design is not suitable for protection using coatings	1.5
Battery Compartments -Corrosion of Deck and sump over 10mm deep	YES	-Galvanic Corrosion -Pitting corrosion	-Detail design does not allow battery acid to drain freely -Maintenance routines need refinement -Mechanical damage of protective coatings	0.5

Photo 4- Bilge Plating-pitting corrosion

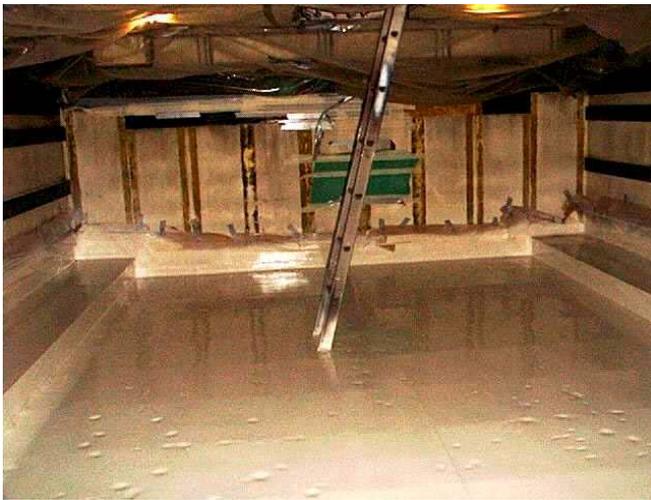
Photo 5- Battery Compartment- pitting corrosion

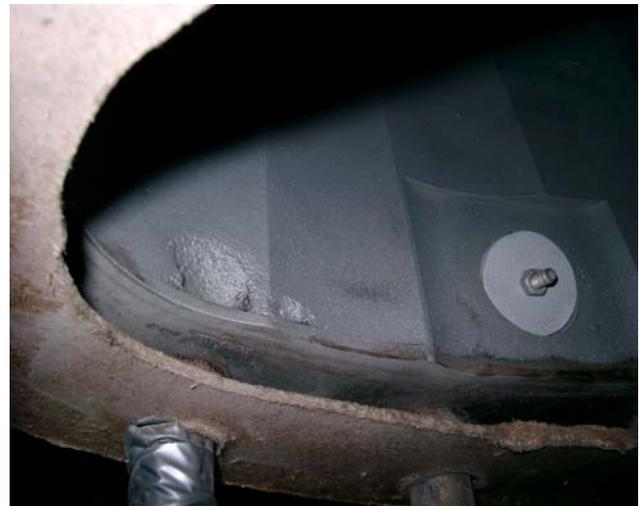
Photo 6-SSE Forging-galvanic corrosion
