Geraldton Concrete Silos Remediation:

A Case Study in The Structural Strengthening and Concrete Repair Practices Utilised for the Ongoing Operational Efficiency and Durability of Concrete Silos

J Barry, S Robertson & A Mesic
Freyssinet Australia Pty Ltd

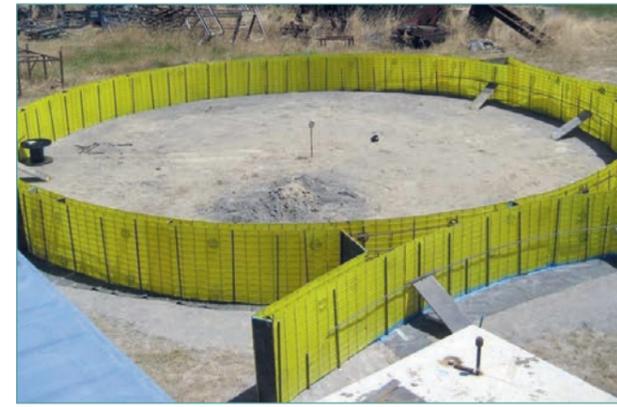
In order to verify the Freyssinet techniques for repair and strengthening initial works included the construction of a prototype off site to confirm the accuracy of coring of the interconnecting diaphragm between silos as shown in Figure 1.

Figure 1 - Construction of prototype.

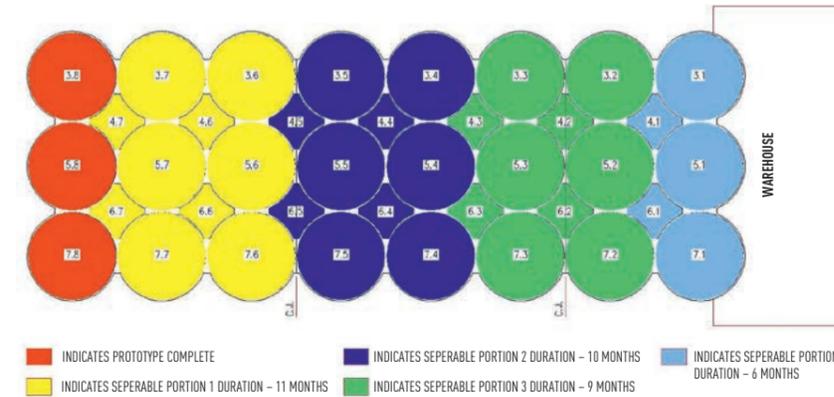
Figure 3 - Breakup of each phase of works.

Works on site commenced in 2008 on the first three silos as part of the initial 18 month 'proto-type' phase. This phase was then followed by the 'full scale works' whereby the overall works package was split into four distinct separable portions (SP1 - SP4) with each addressed as sequential independent schemes as illustrated in Figure 3.

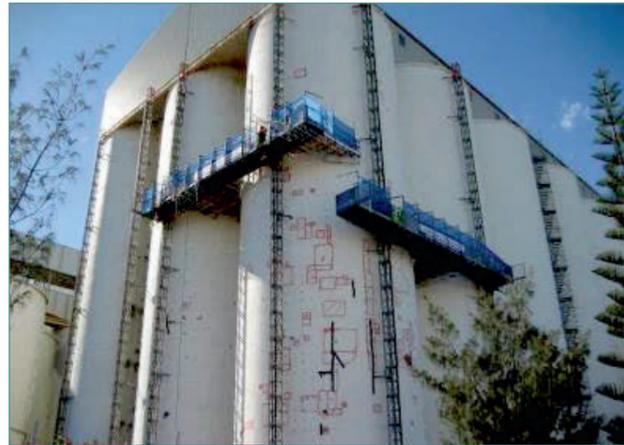
Figure 7 - 'Prototype' phase profiled mast climber system.

During the 'prototype' phase of the works profiled mast climbers (Figure 7) were utilised to access the repair areas. However it quickly became apparent that this access system was not the best solution for a project of this magnitude. With such large areas of repair to be completed, the mast climber system didn't allow for

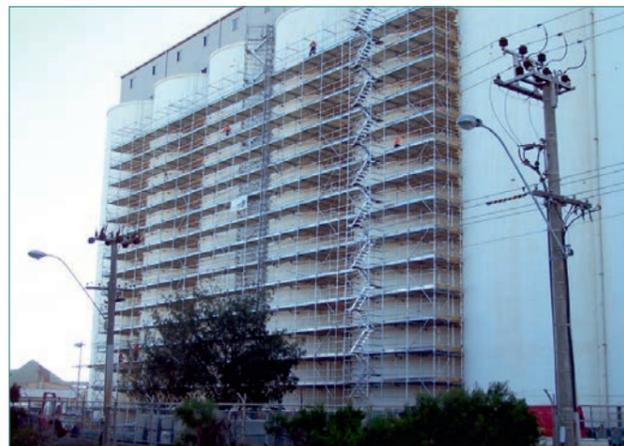
the autonomy required to work on multiple work fronts at any given time. Also because of the lower safe working load (S.W.L) of the mast climbers a traditional scaffold access system (Figure 9) was utilised for SP1 - SP4.

Figure 9 - Typical scaffold access on site (prior to encapsulation).

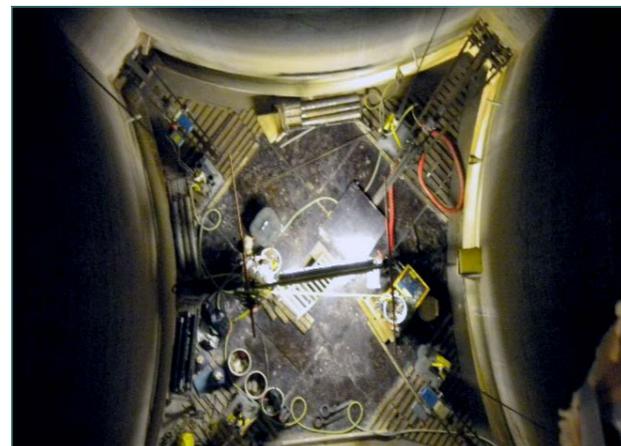
Another unique challenge was the access system for the internal star cells. Access into these areas was a difficult challenge due to the confined space nature of the works. Access doors at the base of each cell allowed for scaffold material to be passed into each cell and a scaffold 'donut' platform (Figure 10) to be constructed to suit the cells configuration. Side guides/ rollers and a winch system was used to traverse the 'donut' up and down the star cell walls. Emergency access was by means of rope access system in/out of the escape hatch at the top of each cell created by removal of each silos grain feed chutes.

Figure 10 - Star cell scaffold platform.

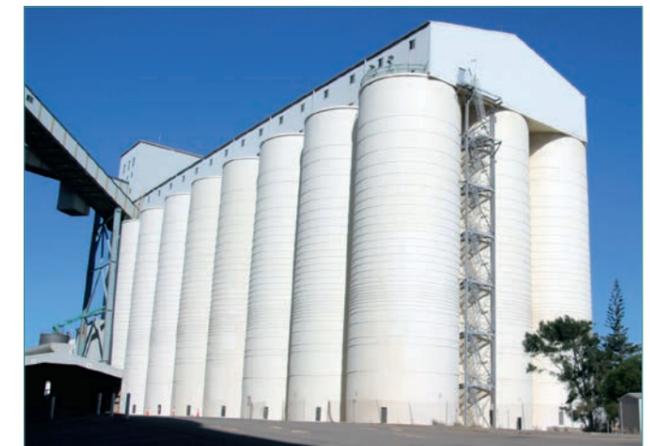
Figure 12 - Project at completion.
