## Lemonthyme Power Station Penstock Internal Corrosion Coating Replacement

Lemonthyme Power Station is a 51MW power station located on the Mersey River in the central north west of Tasmania.

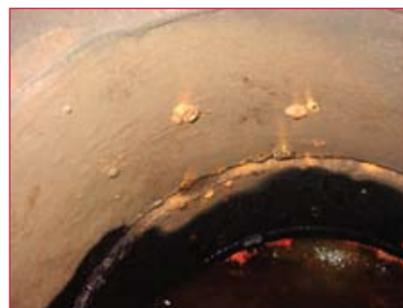
Examples of some of the more severe rust nodules created by failure of the corrosion system

An inspection in 2002 identified the beginning of corrosion issues. The coating was failing and warranted replacement at the earliest planning opportunity. A more detailed inspection inside the Lemonthyme Penstock was conducted in February 2005. This was limited to the flatter

areas of the penstock as the interior was very slippery and the steeper sections (45°) were too dangerous to inspect. The inspection of these areas revealed random areas of pitted corrosion with some of the pitting having caused up to 4mm of steel loss.

Analysis of the potential failure mechanisms of the penstock indicated that further loss of thickness of the steel could result in failure of the penstock as a result of negative pressures that might occur during water hammer effects resulting from a station trip and sudden stop to the flow of water. It was therefore determined that removal of the existing internal coating and replacement with a new corrosion protection system was necessary to sustain the asset for the future.

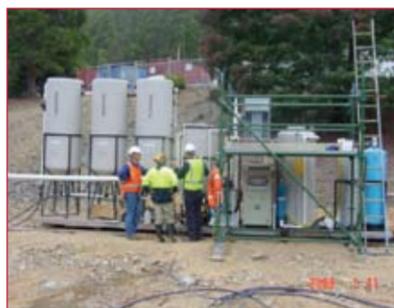
On-site treatment plant

Removal of the existing coal tar enamel and epoxy system was carried out with the use of Ultra High Water Pressure (UHWP) robotics. Removal in such a manner resulted in the need to treat both solid and liquid waste. Coarse solids were removed directly from the penstock. Liquids were pumped to a purpose-made settling pond to remove additional solids, then treated in a purpose-built onsite treatment plant, before emptying the treated water in to storage tanks.

The final treated product was tested for "cleanliness" before discharging in to the local river system. The treatment plant was designed to remove Aromatic Hydrocarbons, Chlorobenzene, Polychlorinated Biphenyls and similar contaminants. The treatment plant proved so successful the treated water was "cleaner" than the water in the existing stream.

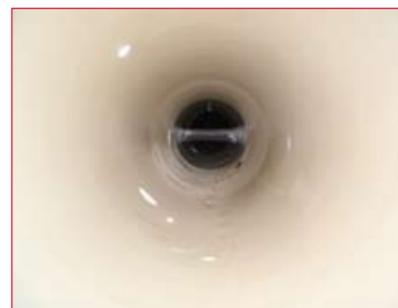
Completed section of penstock with butterfly valve in background

The new coating system was immediately applied. This consisted of a primer coat and one coat of Interline 975<sup>®</sup> from International<sup>®</sup> Protective Coatings with a total dry film thickness (dft) of 500 microns. Application was predominantly carried out by robotics providing consistent coating thickness and minimal OH&S issues.

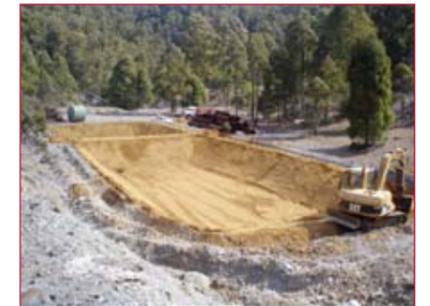
Settling ponds under construction

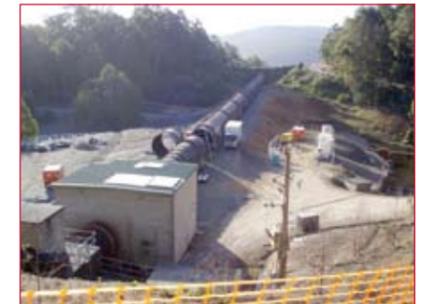
Upstream "flat" section of the penstock

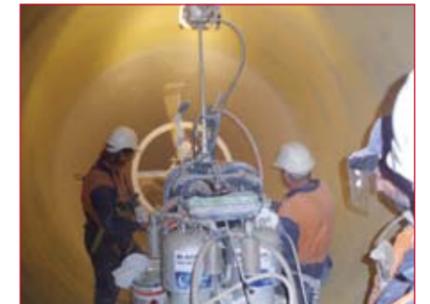
Painting robot

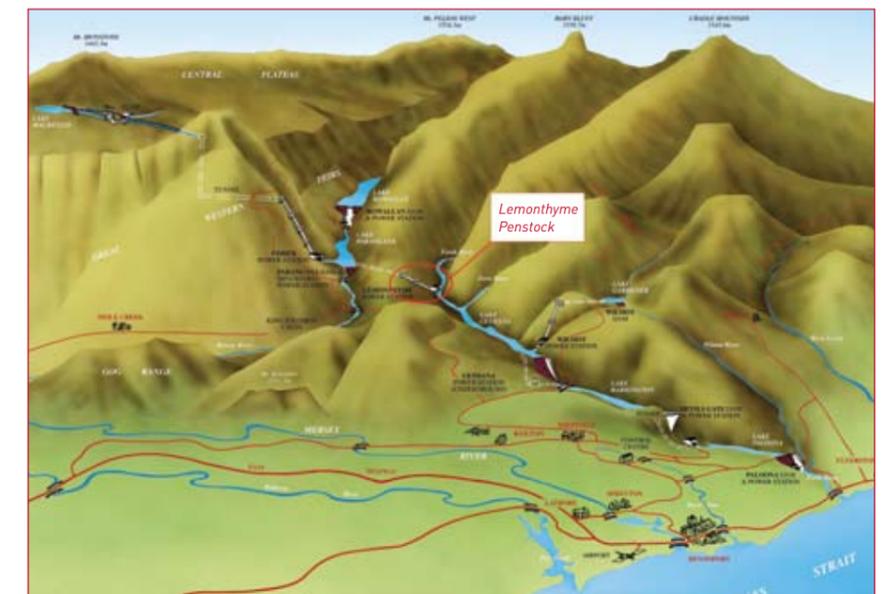
Figure 1: Schematic showing Lemonthyme in the Mersey-Forth Power Scheme

The station contributes approximately three per cent of Hydro Tasmania's annual revenue. The station is placed within the Mersey Forth chain of stations that then contributes a further eight per cent of revenue to the business (Refer Figure 1). The passage of water through the station, as opposed to by-passing the generator, is a key component of delivering maximum revenue from run of river systems that do not have large storage reservoirs.
