Extending the Life of a Wharf Asset for PNG Ports

AECOM recently developed an asset management strategy providing an extra 30 years service life to a vital berth servicing approximately 50 percent of container movements among Pacific Island nations.

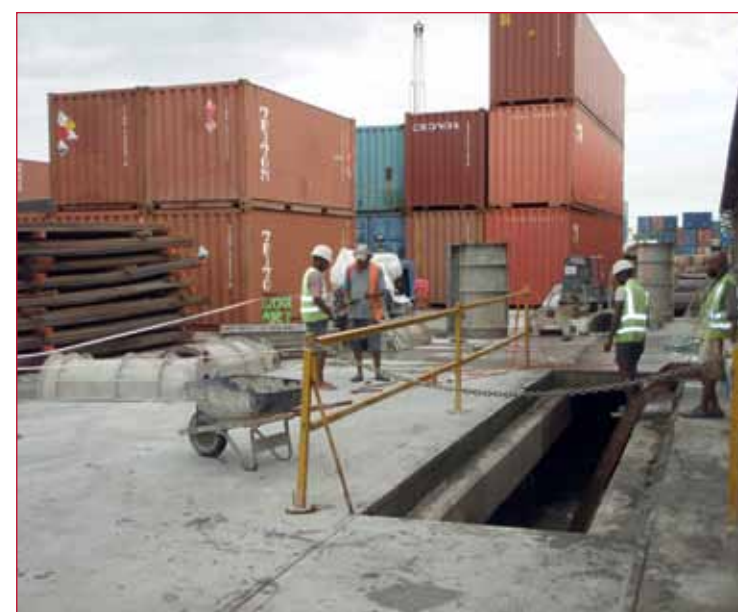
Access was required to the soffit of the wharf
