# University Galvanized to Face the Future

As part of the Arts West Redevelopment project, the University of Melbourne has renovated the Arts faculty building on Medical Road in the main Parkville campus. A stunning visual feature of the new building is the louvered façade on three sides; the steel sections of each louvre have been shaped so that they form part of a series of 3D images that can be viewed from different angles as people walk around the building.

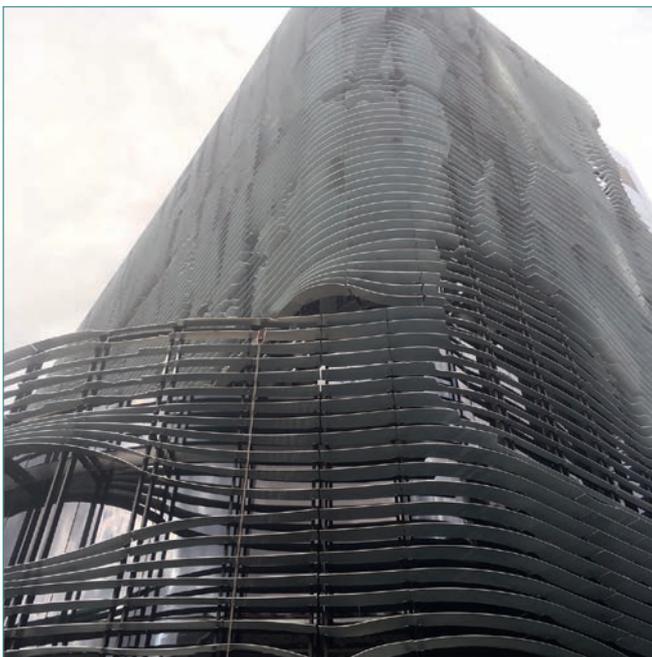
Some of the stylised figures embedded in the panels of the redeveloped University of Melbourne Arts faculty building.

had to be taken off in such a way that they could be lifted up the building without double handling.” The panels were packed with spacers and carpet so that the coating would not be damaged as the client wanted to maintain an “architectural” look and finish. The sequencing was a critical aspect of the project to ensure the shaped sections correctly formed the embedded image.

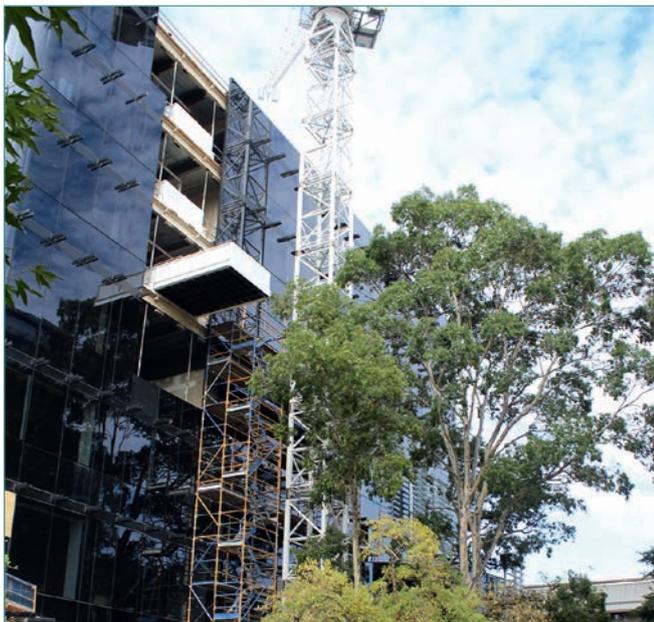
*The cramped construction site drop zone that had to be negotiated by the semi-trailers delivering the galvanized sections.*

While the iconic façade on the Arts faculty building was being installed, Reilly had to contend with the constraints of restricted site access for the trucks delivering the oversize galvanized sections. The University of Melbourne is located in a leafy area north of Melbourne’s CBD, but most of the buildings are nestled close together with narrow laneways between them making it difficult to manoeuvre large vehicles.

“All the façade sections were numbered as they had to be installed in a very precise sequence,” Reilly added. “It was a challenge to get the semi-trailers in and unload the steel because they

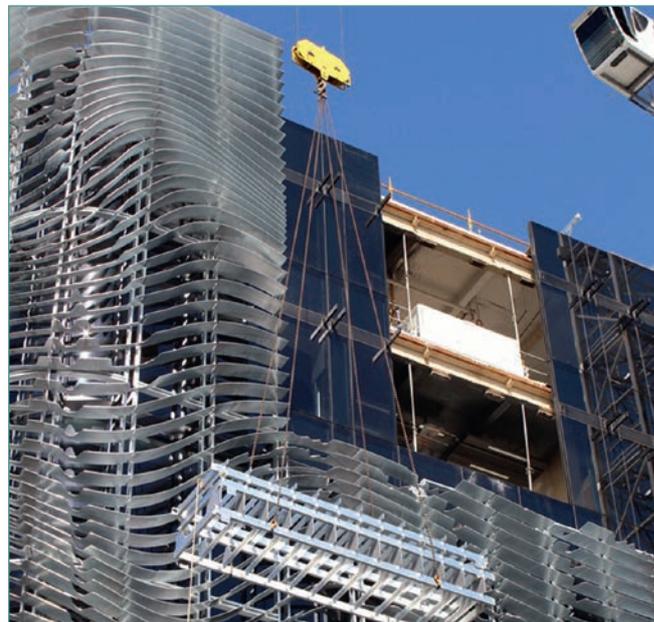
*Sections of the galvanized façade being lifted into place by crane.*
